ENVIRONMENTALLY SENSITIVE EQUIPMENT FACILITIES
IN THE
CIA HEADQUARTERS BUILDING
LANGLEY, VIRGINIA

Real Estate and Construction Division
Office of Logistics

5 March 1973

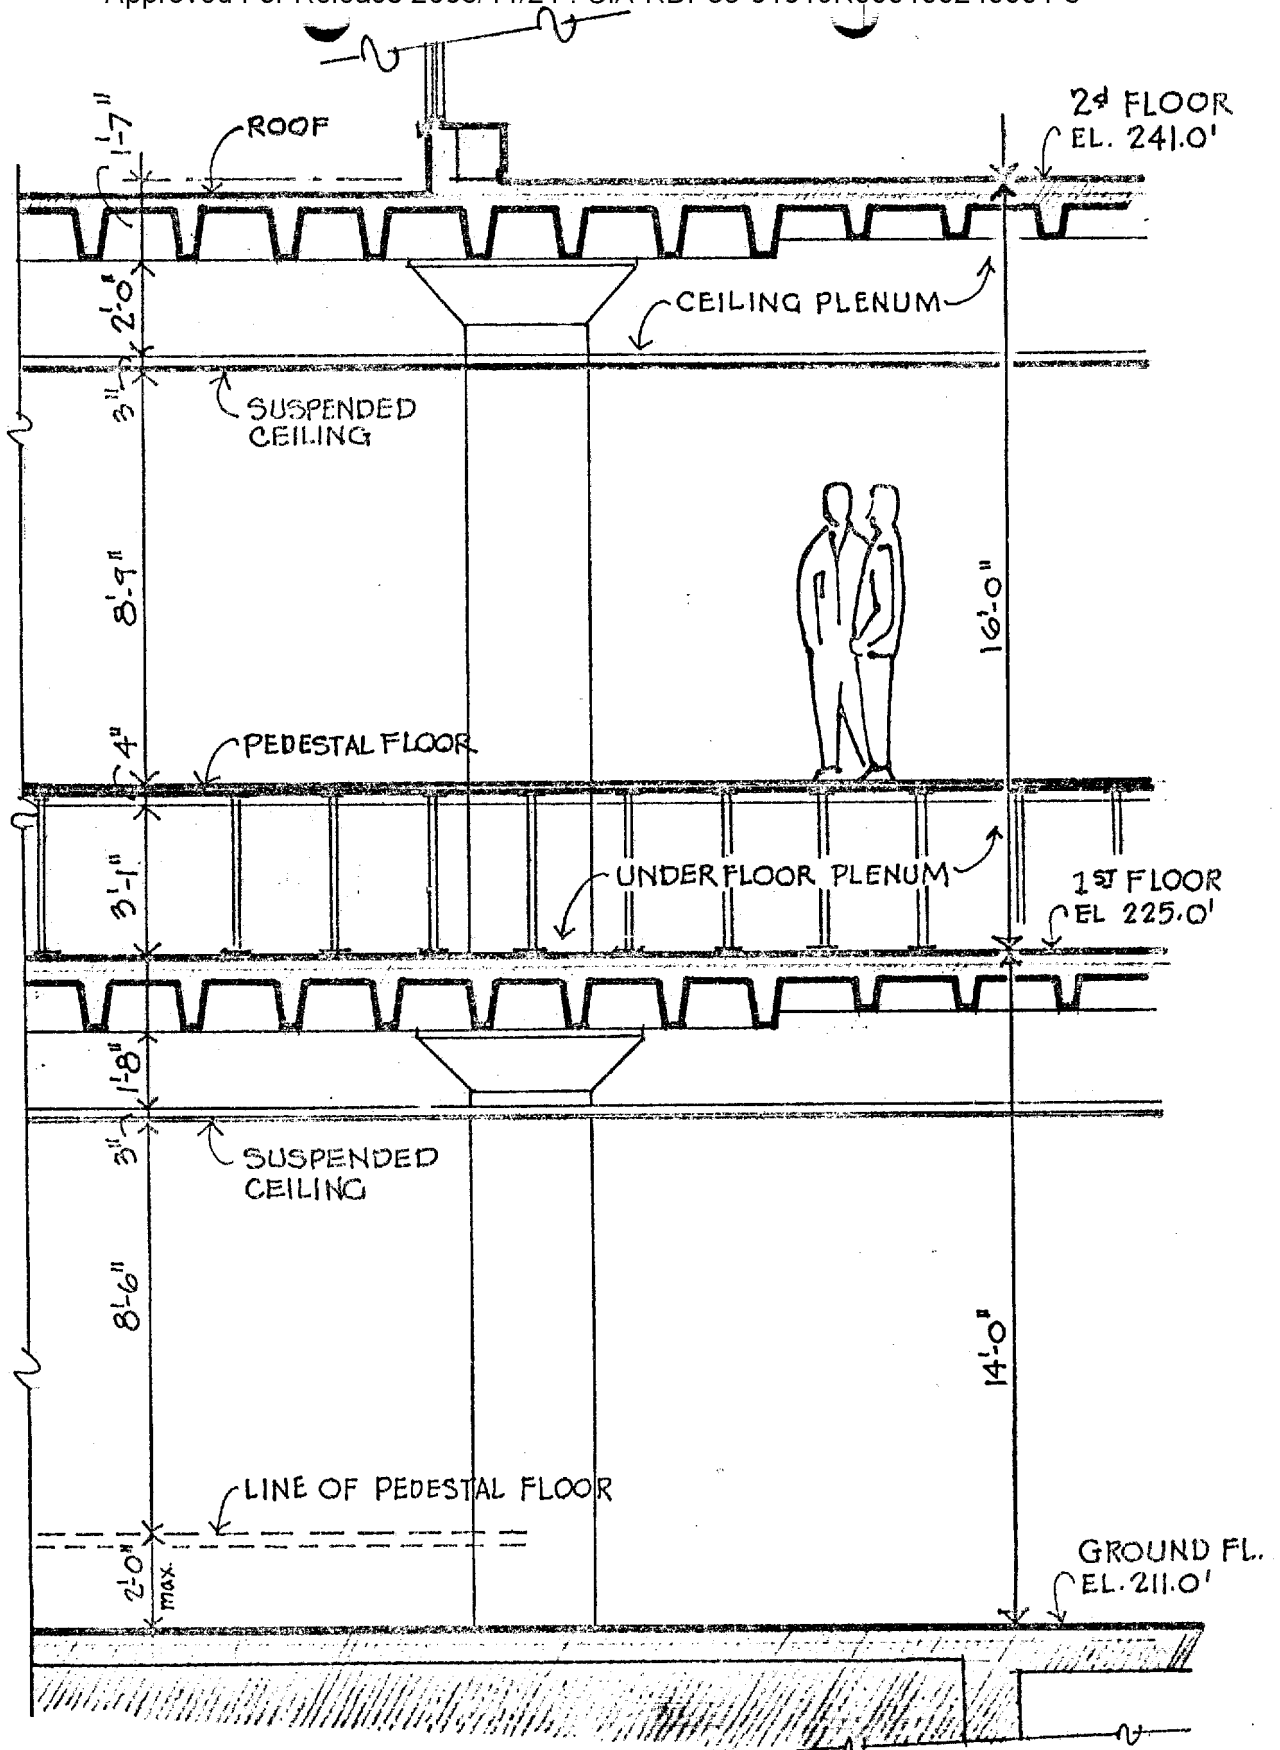
fig. 6.

an unacceptable practice in computer areas because of dust accumulation, aesthetics, and, as with loose cabling underfloor, comingling of power and signal cable. (See Figure 6 showing overhead cables in the AND area.) Figures 4, 5, and 6 show underfloor conditions in the OCS computer center, the worst of the ESE areas in this respect. In addition to power and signal cable, this underfloor area includes high pressure chilled water in rubber hoses plus underfloor water detection wires and a smoke detection system. Cabling is so congested that underfloor air distribution is affected. Should a high pressure hose burst or blow off from its connection, major malfunctions would certainly occur, shock hazard would be substantial, and damage assessment and restoration of operation would involve a major undertaking.

View 3 - Underfloor Conditions OCS Area GC03
